**SMART composite (Self-bonding Material for Atraumatic Restorative Treatment) restoration of children's primary molar teeth after minimal caries removal: Class IIa device in a single site, single arm study. Stage 1 Assessment of Safety**

Paul Ashley, Wendy Xia, Nabih Alkhouri, Anne Young

Clinical trial number 228909

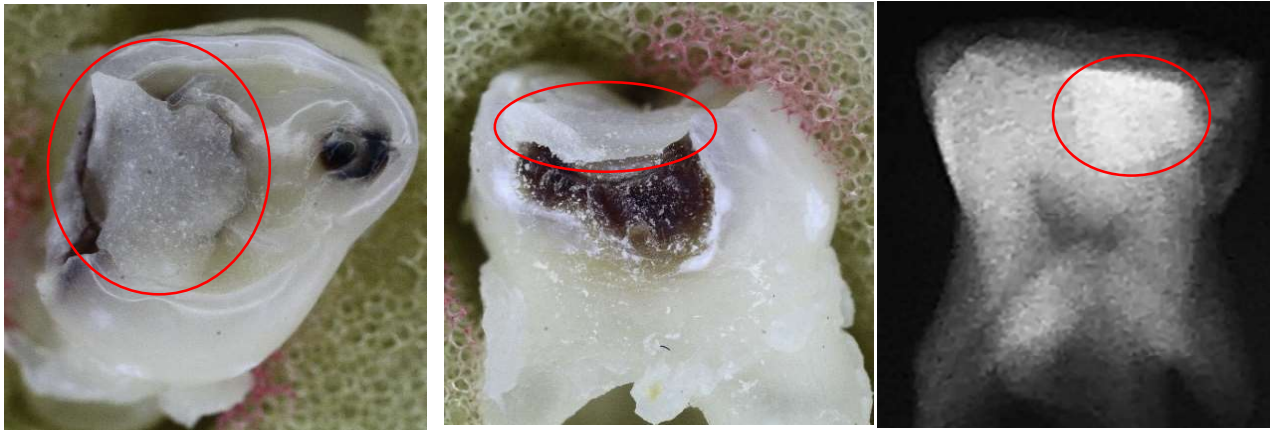
Figure 3A Patient 3 – from left to right - light microscopy of occlusal and distal surfaces and X-ray image with red rings indicating the composite. From the Xray, the composite placement is deeper in the centre of the tooth than on the distal surface.

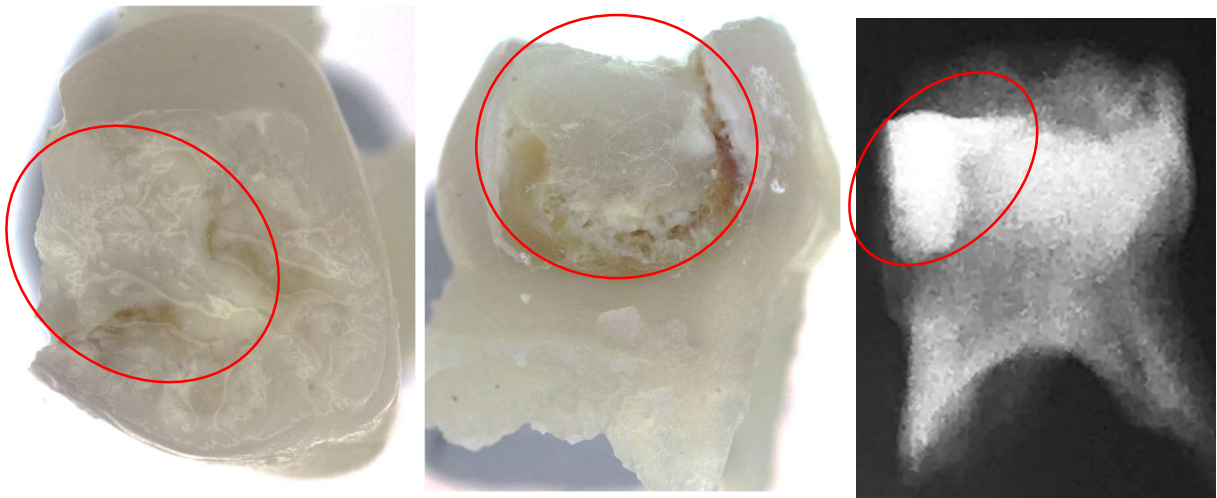
Figure 6A Patient 7 From left to right - light microscopy of occlusal and distal surfaces of tooth and X-ray image. From the X-ray the restoration has interlocked well with the highly carious tooth structure. Whilst the restoration on the distal edge is only thin near the gingival margin, upon close examination there appears to be some composite resin covering all the carious dentine.
